# Mayne Tree Expert Company, Inc.

April 13, 2020  
(Updated August 12, 2020)

RE: GARY ERNST, DOLTON AVENUE, LOT #1, SAN CARLOS (UNINCORPORATED)

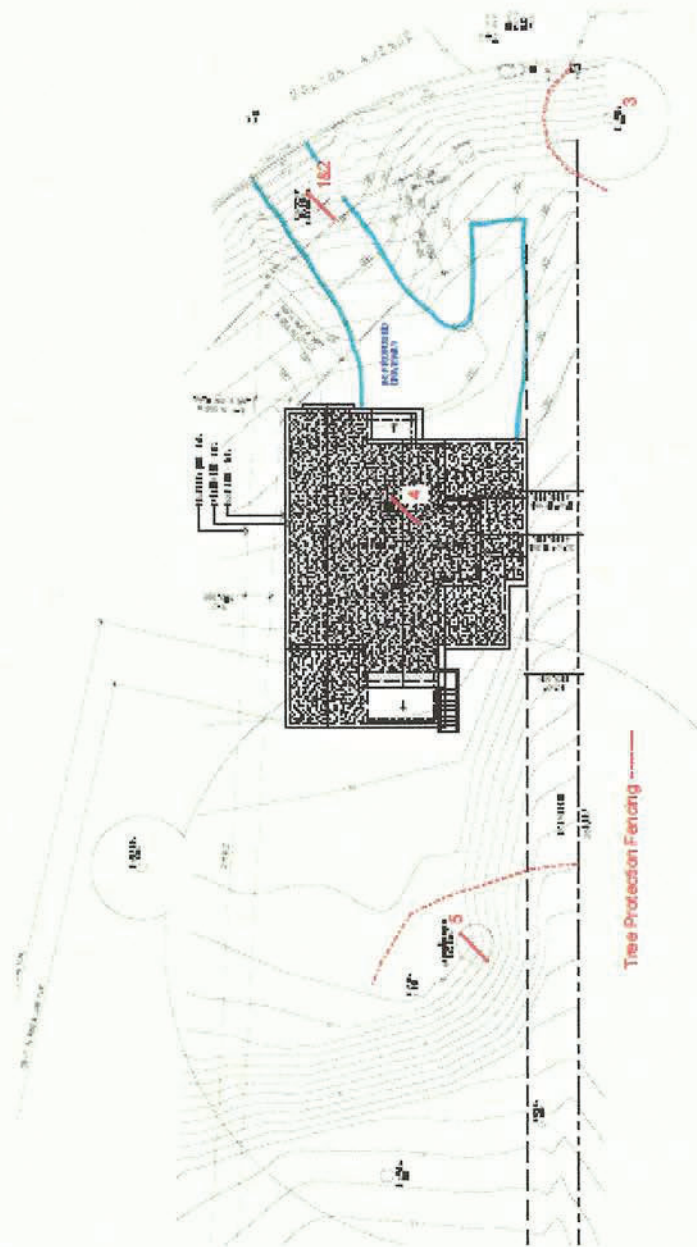
See tree numbers & fencing site plan (pdf) attached to email with this letter.

Tree protection would require chain link fencing installed along the road and around the dripline of the tree. If kept, tree #5 can be fenced off along the flat area above the tree. (See site plan.) These areas are off limits to all construction equipment and materials.
