**COUNTY OF SAN MATEO  
PLANNING AND BUILDING DEPARTMENT**

**SUBJECT:** Consideration of a Grading Permit, pursuant to Section 9290 of the County Ordinance Code, involving 1,443 c.y. of cut and 1,725 c.y. of fill to re-set golf course contours and re-landscape at The Olympic Club at 599 Skyline Blvd. The project will be implemented during the rainy season. Two (2) significant trees are proposed for removal. A larger portion of the project is in within the limits of the City and County of San Francisco. The site is located along Skyline Blvd., a County-designated Scenic Corridor. The California Coastal Commission has issued a CDP Waiver for this project.

County File Number: PLN 2022-00271 (The Olympic Club)

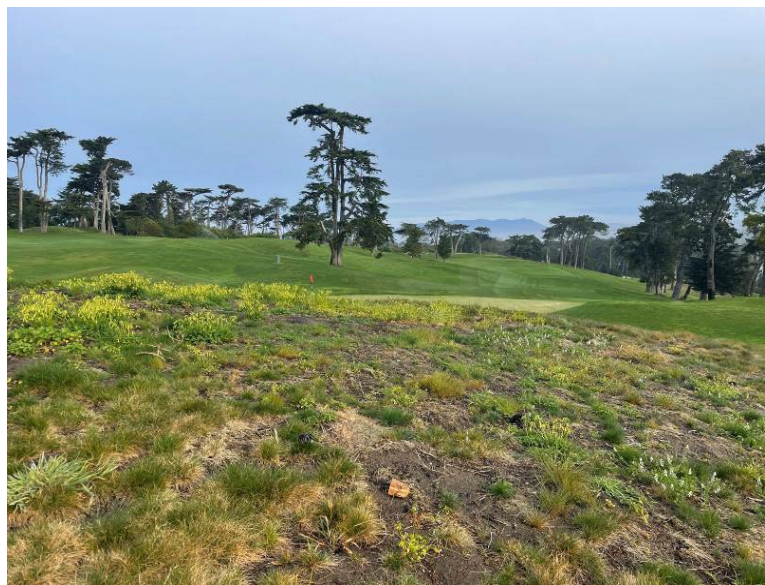
The ruderal/unmaintained land cover type in the Study Area is scattered throughout the developed golf course areas and borders the drainage ditch. This land cover type is dominated by non-native grasses and forbs such as: curly dock (*Rumex crispus*), upright veldt grass (*Ehrharta erecta*), and goosefoot (*Chenopodium murale*). Some areas contain native species known to grow in disturbed areas including: California poppy (*Escholzia californica*) and miner's lettuce (*Claytonia perfoliata*). This land cover type is not considered

**Photo 1. Ruderal/unmaintained land cover type adjacent to developed golf course greens and Monterey cypress, taken on April 4, 2022.**

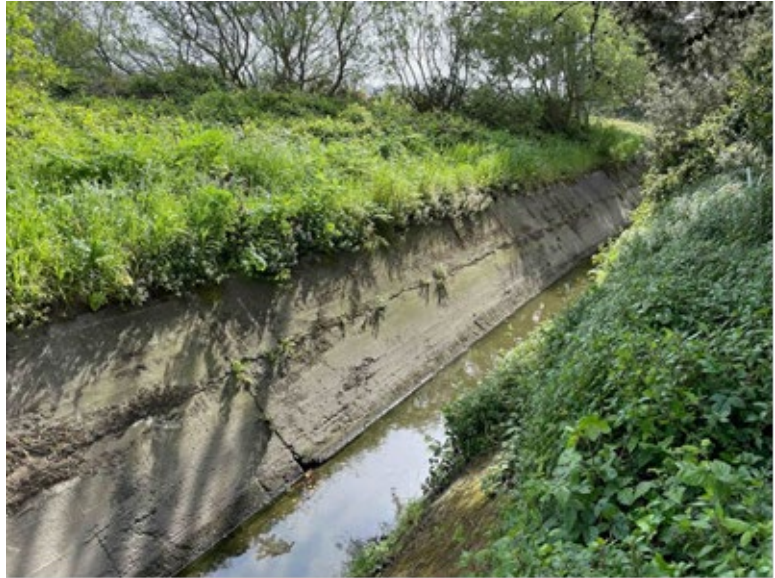
- There is no aquatic breeding habitat within the Study Area that could support populations of California red-legged frog (CRLF). There is a concrete-lined drainage ditch on the eastern boundary of the Study Area. This drainage ditch has steep (~60°) banks over 6-feet in height and is separated from the Study Area by a 2-inch, chain-linked fence hindering dispersal/movement. The drainage ditch does not provide suitable protection from predators or foraging habitat for this species due to the water level typically being 2-3 inches deep.

**Photo 3. Drainage Ditch, taken on April 4, 2022.**

In addition, the water flow rate would be too fast in the event of a heavy rain event because of the absence of structures that could slow the speed of water (e.g., large logs, rocks). According to CNDDDB (CDFW 2022), the closest occurrence for CRLF is 3.8 miles north of the Study Area in Golden Gate Park. However, the Study Area is outside the dispersal range of CRLF, and urban development around the golf course provides an effective barrier to CRLF movement between source populations and the Study Area. Due to the lack of connectivity with other suitable habitats, there is an unlikely potential for CRLF to be present in the Study Area or in its immediate vicinity.

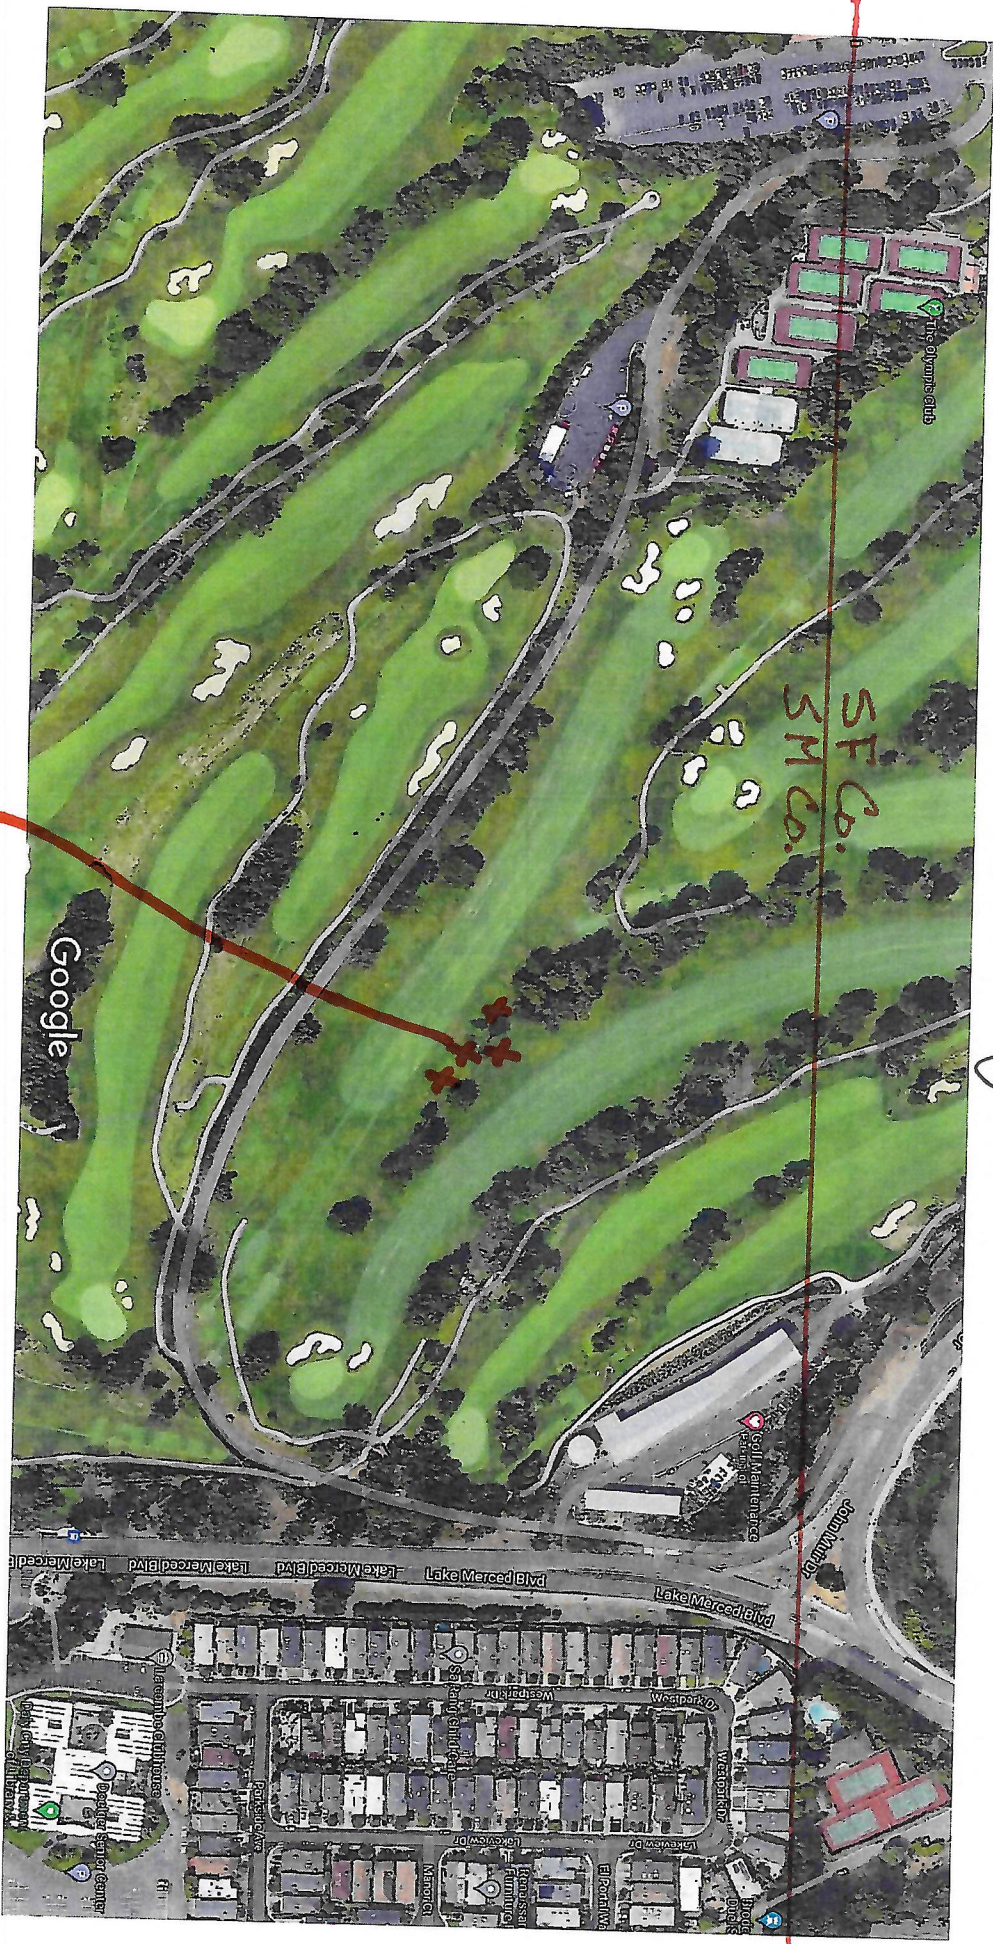
# Tree Replanting Plan

4-15 gallon Monterey Cypress Trees to be planted

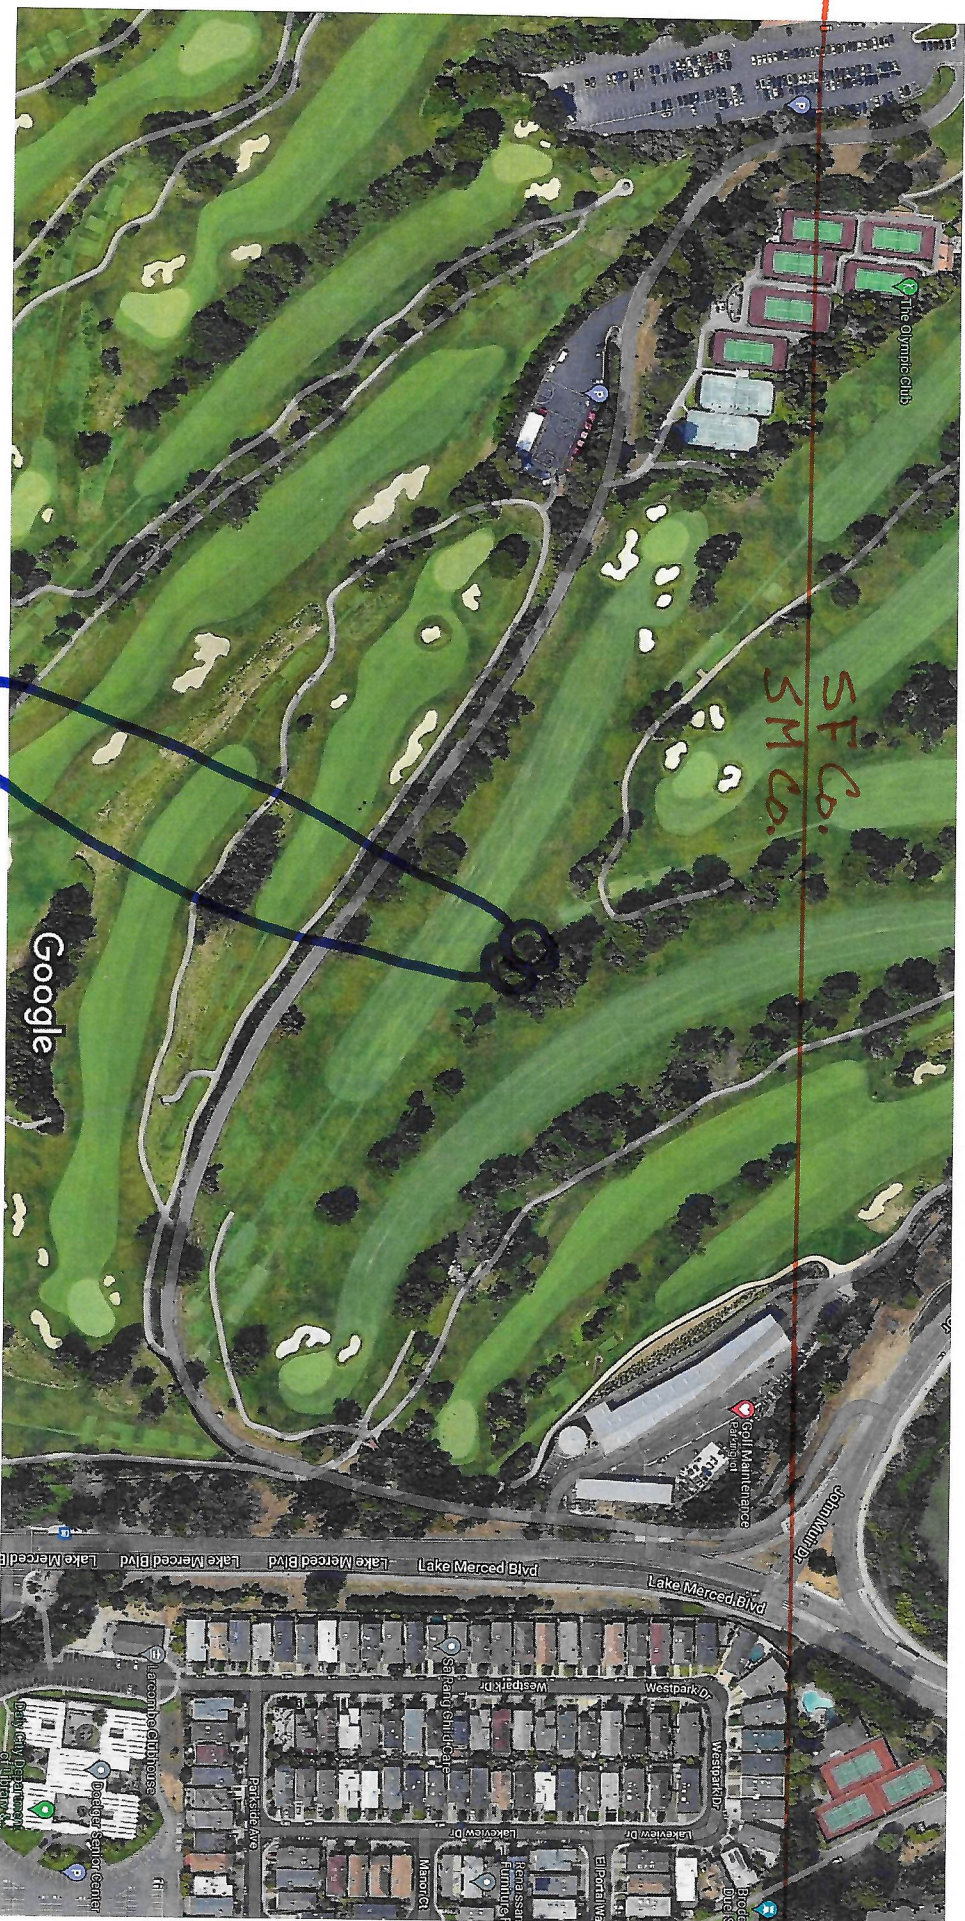
# Tree Removal Plan

26" Diameter Monterey Cypress to be removed  
 28" Diameter Monterey Cypress to be removed

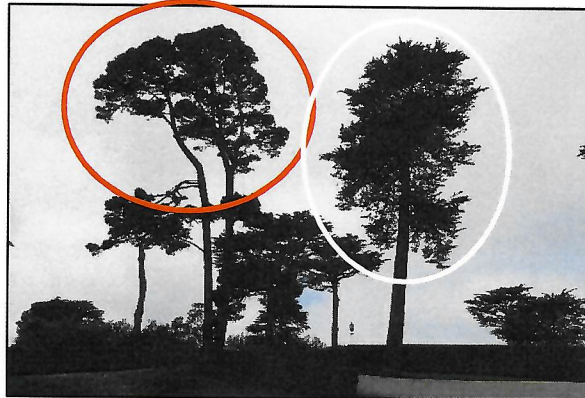
**Photo 3.** Looking south at Monterey pine #1 (red circle) and Monterey cypress #2 (white circle).

Monterey cypress #2 is 45 in. and old in development. The base of the trunk is located immediately adjacent to a four ft. high retaining wall. A large basal cavity is present on the wall side. Overall condition is fair. The canopy is dense and concentrated near the top of the tree.

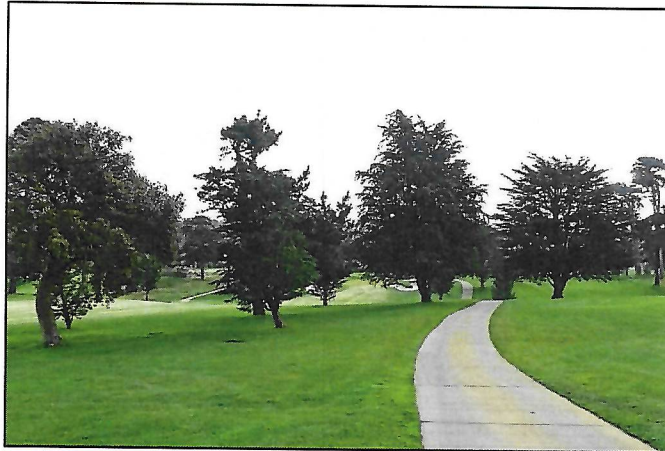
**Photo 5.** Looking northeast along cart path on #7. Four trees are located on either side of the path. Red-flowering gum #1376 is at the left edge of the photo.

To the north are red-flowering gum #1376, Monterey cypress #1377, and 1379; and Monterey pine #1378. The red-flowering gum is 24 in. in diameter and in poor condition. Two scaffold branches on the west have failed. The codominant attachment at 12 ft. has split apart. Monterey pine #1378 is 31 in., old in development, and in poor condition. The main stem has failed, leaving a poorly structured crown that is one-sided to the south. Monterey cypress #1377 is 13 in., semi-mature in development and in good condition. A lean to the west is partially corrected. Monterey cypress #1379 is 34 in. and mature in development. Tree condition is good. Low lateral branches sweep upright.

To the south of the cart path are Monterey cypress #107, 1373, 1374, and 1375. Trees #1373, 1374, and 1375 are semi-mature in development with trunks of 9½, 20 and 15 in. Tree condition is either good or excellent. Monterey cypress #107 is 41 in. and in good condition. Low lateral branches sweep upright and multiple stems arise at 6 ft., resulting in a dense mass of stems.

Eight trees are present on the right side of the fairway with four trees on the north side of the cart path and four on the south (Photo 5).

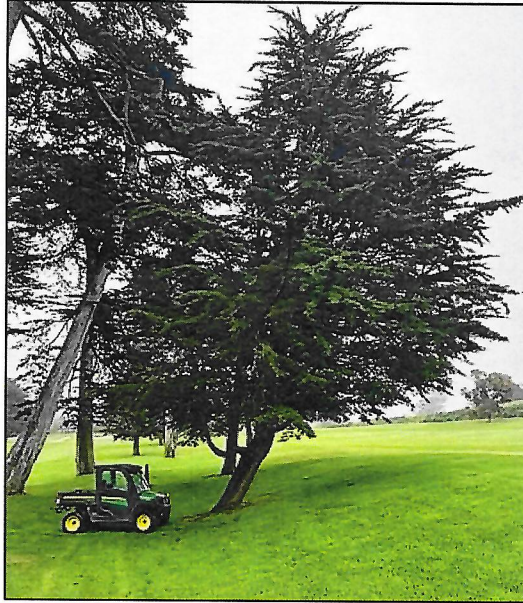
**Photo 7.** Monterey cypress #244 leans sharply towards the fairway.
