**REVISED GEOLOGIC EVALUATION
ENVIRONMENTAL IMPACT REPORT
HIGHLAND ESTATES RESIDENTIAL
DEVELOPMENT PROJECT
San Mateo County, California**

**Impact Sciences, Inc.
Oakland, California**

**27 August 2009
Project No. 4872.02**

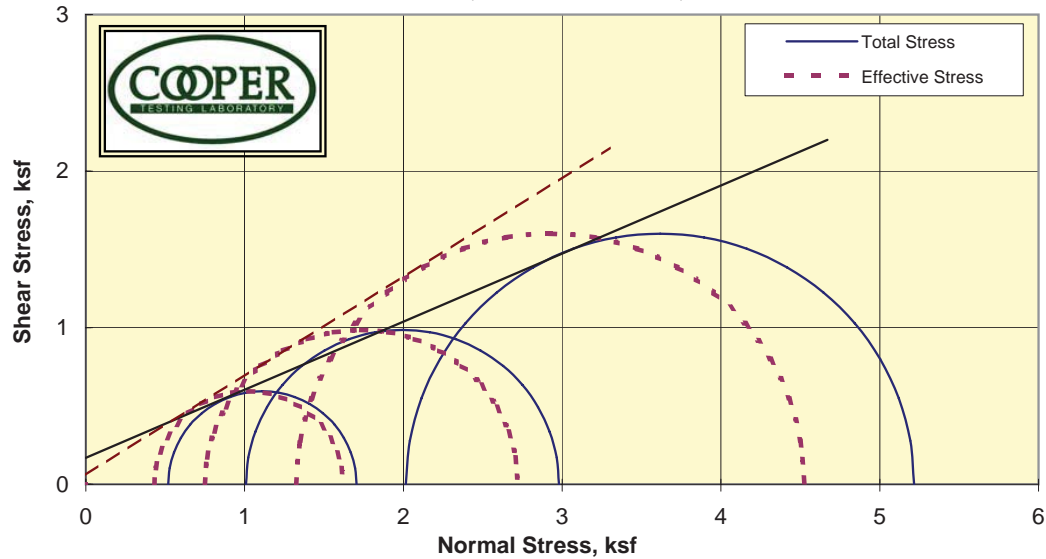
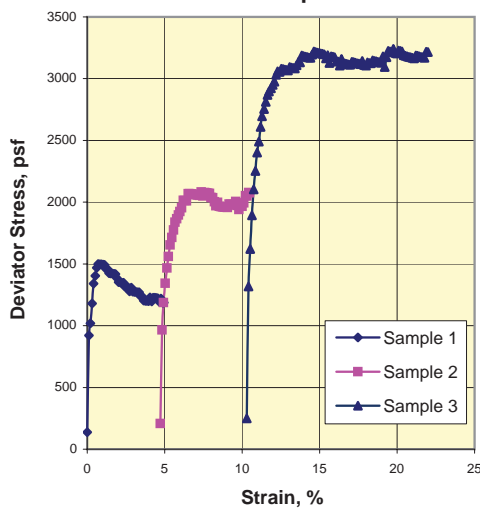
Triaxial Consolidated Undrained

Stress-Strain Response

Sample:	1	2	3
MC, %	15.0		
Dry Dens., pcf.	109.2		
Sat. %	74.6		
Void Ratio	0.543		
Diameter in	2.37		
Height, in	5.00

Final		
MC, %	22.0	21.3	20.4
Dry Dens., pcf.	109.5	110.9	112.7
Sat. %	100.0	100.0	100.0
Void Ratio	0.594	0.574	0.551
Diameter, in	2.37	2.41	2.45
Height, in	4.99	4.77	4.53
Cell, psi	62.0	65.4	72.4
BP, psi	58.4	58.4	58.4

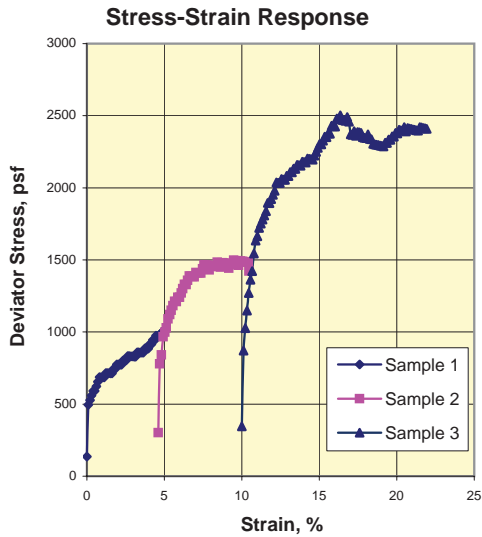
Triaxial Consolidated Undrained

Sample:	1	2	3
MC, %	10.2		
Dry Dens., pcf.	123.8		
Sat. %	76.5		
Void Ratio	0.360		
Diameter in	2.38		
Height, in	5.00		
	Final		
MC, %	19.7	18.8	17.6
Dry Dens., pcf.	124.6	126.9	130.1
Sat. %	100.0	100.0	100.0
Void Ratio	0.532	0.509	0.475
Diameter, in	2.37	2.40	2.43
Height, in	5.00	4.78	4.55
Cell, psi	42.0	45.4	52.4
BP, psi	39.0	38.6	38.7
	Effective Stresses At:		
Strain, %	5.0	5.0	5.0
Deviator ksf	1.001	1.466	2.276
Excess PP	-0.043	0.202	0.576
Sigma 1	1.476	2.244	3.673
Sigma 3	0.475	0.778	1.397
P, ksf	0.976	1.511	2.535
Q, ksf	0.500	0.733	1.138
Stress Ratio	3.106	2.886	2.630
Rate in/min	0.001	0.001	0.001
Total C	0.23	Effective C	0.08
Total Phi	17.3	Effective Phi	25.2

Job No.: 010-1055 **Date:** 8/3/2009
Client: Treadwell & Rollo **BY:** DC
Project: Highland Estates - 4872.01
Sample: Pit 2;2 @ 15' Light Gray Sandy CLAY near Clayey SAND (Silty)
Remarks: ** Staged Test ** Strengths picked at 5% strain.
 Remolding Target= 124 pcf @ 10%.

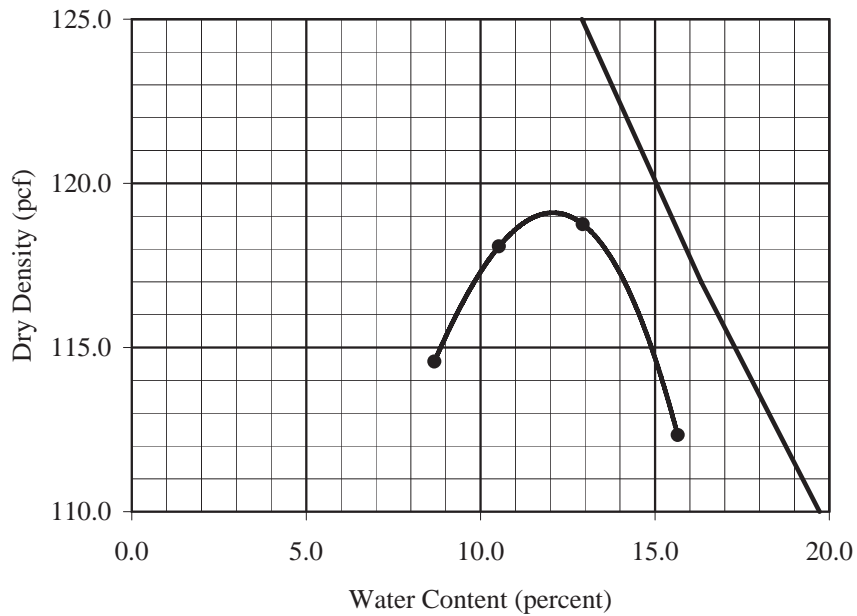
Figure B-3

Sample Identification		Soil Data				Test Specifications	
Bulk Sample No. 2 Tested 7/1/2009 by EKG		LL = ___	Gs (assumed) = 2.7			ASTM D 1557-91 Procedure A Hammer Weight: 10 lbs Hammer Drop: 18 in Number of Layers: 5 Blows per Layer: 25 Comp. Mold Size (ft ³) 0.033	
		PI = ___	% > 3/4" sieve =				
Test Data							
	1	2	3	4	5		
Wt. Mold + Soil (lb)	13.54	13.74	13.86	13.72			
Wt. Mold (lb)	9.39	9.39	9.39	9.39			
Wet Wt. Soil + Dish (gm)	618.3	732.3	572.3	644.6			
Dry Wt. Soil + Dish (gm)	574.6	669.3	515.2	566.3			
Wt. Dish (gm)	71.0	71.0	73.7	66.1			
Dish ID Number	E-3	E-3	D-37	D-32			
Moisture Content (%)	8.7	10.5	12.9	15.7			
Dry Density (pcf)	114.6	118.1	118.8	112.3			
Test Results						Soil Classification	
						Clayey Sand (SC), brown	
Test Results						Soil Source	
		Uncorrected		Rock Corrected		Test Pit 2, Lab Sample 1 (8')	
Maximum Dry Density (pcf)		119		-			
Optimum Moisture Content (%)		12		-

Soil samples were re-examined in our office to confirm field classifications and to select representative samples for testing. Laboratory tests were performed on selected soil samples to determine maximum density and moisture relationships for a proposed buttress fill landslide repair and total shear strength and effective shear strength of remolded samples prepared to approximately 90% of the maximum density and 3% above the optimum moisture to simulate the proposed fill. The geotechnical laboratory test results are presented in Appendix B.
